Description: Sirenusa Condo Complex, St. John, USVI "J" unit is last unit, lower right, behind dark brown area.

Description: "J" units at Sirenusa, St. John. Unit where pesticide was applied is lower, unit where residents were overcome is above.

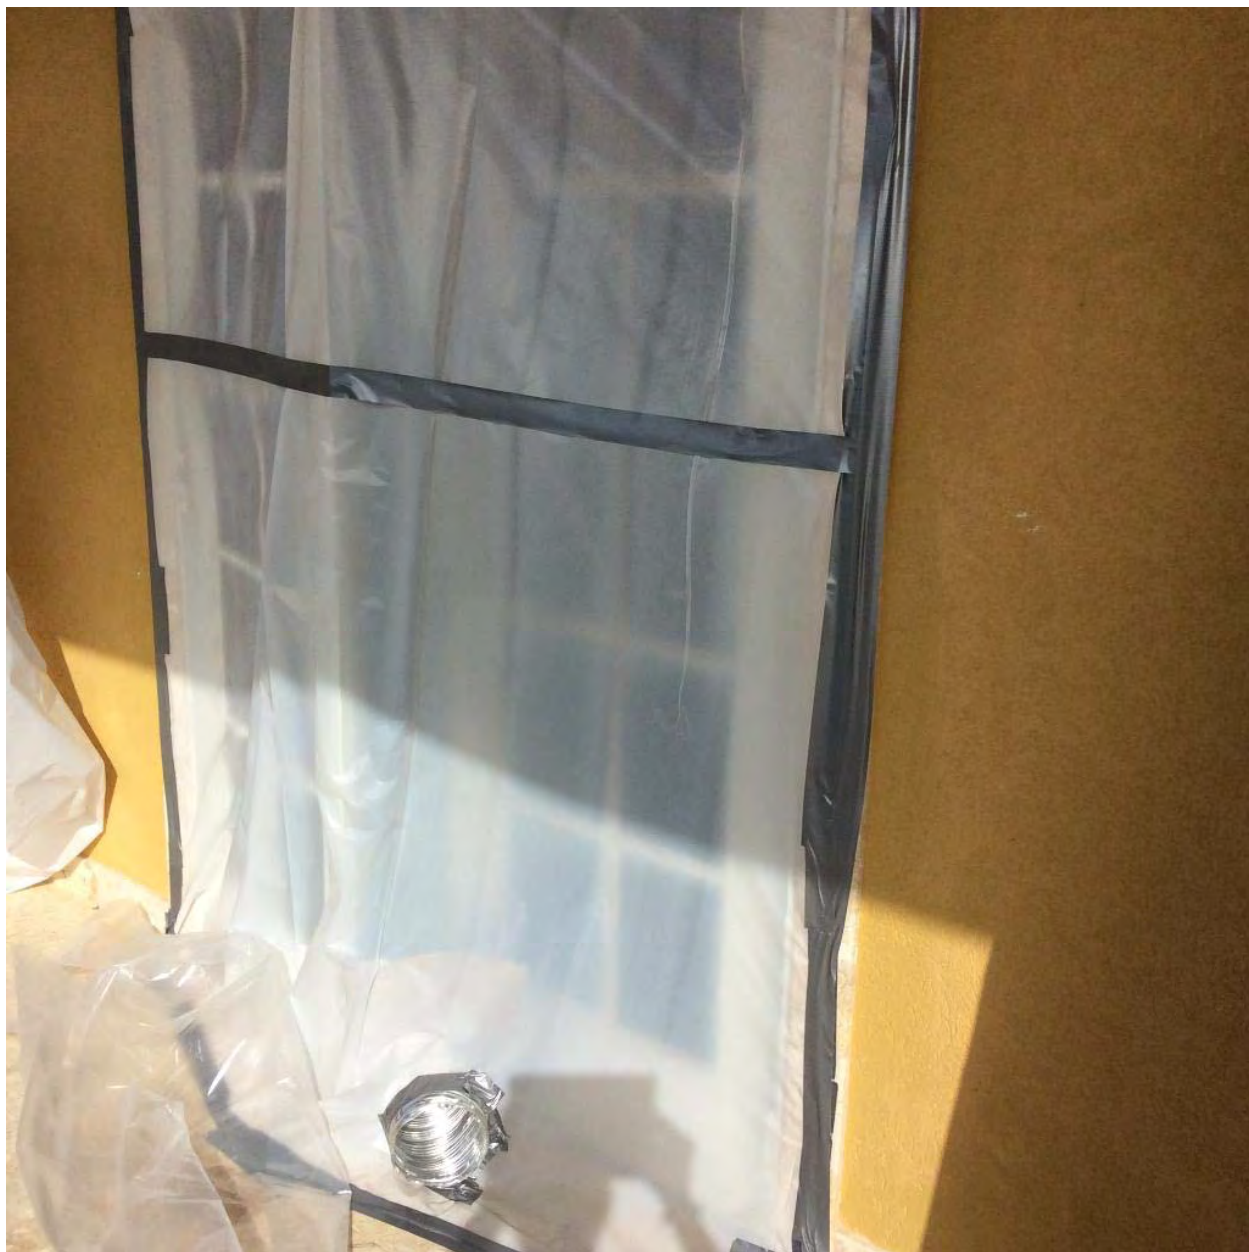
Description: Duct taped window.
